THE CORPORATION OF TAY VALLEY TOWNSHIP  
REQUEST FOR PROPOSAL

ENGINEERING SERVICES FOR THE REPLACEMENT OF BOLINGBROKE BRIDGE

ADDENDUM NO. 1

**(ID 15-072) - Bolingbroke Bridge**

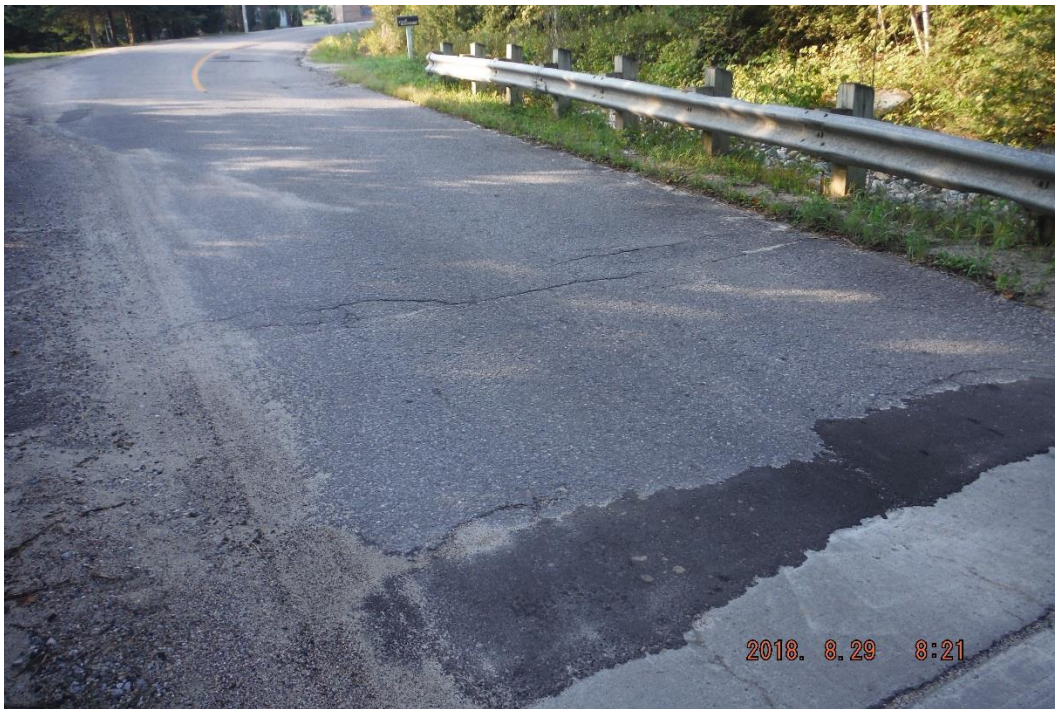
Photo 2: South Approach – Medium to Severe Cracking, Light to Medium Raveling and Asphalt Patch

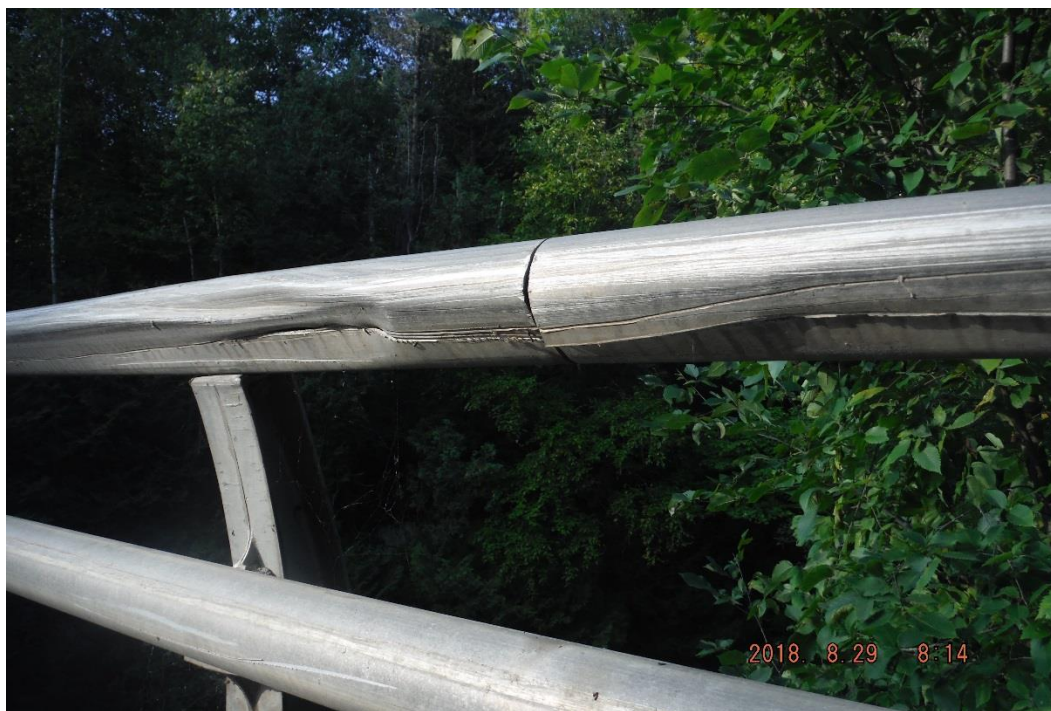
Photo 4: East Railing System – Collision Damage

Element Group:	Barriers	Length:	35.2					
Element Name:	Railing System	Width:	N/A					
Location:	East and West	Height:	N/A					
Material:	Aluminum	Count (items):	2					
Element Type:	3-Rail Aluminum Stanchion	Total Quantity:	70.4		m			
Environment:	Severe	Limited Inspection						
Protection System:						Perform. Deficiencies		
Condition Data:	Units	Exc.	Good	Fair	Poor*			
	m		58.4	8.0	4.0			
Comments:	Several areas of collision damage and light to medium abrasion were noted in both railing systems. Collision damage with a light perforation was observed on the west railing system							
Recommended Work:		Rehab	X	Replace	Maintenance Needs:			
		1-5 years	X	6-10 years	Urgent		1 year	2 years
- Replace

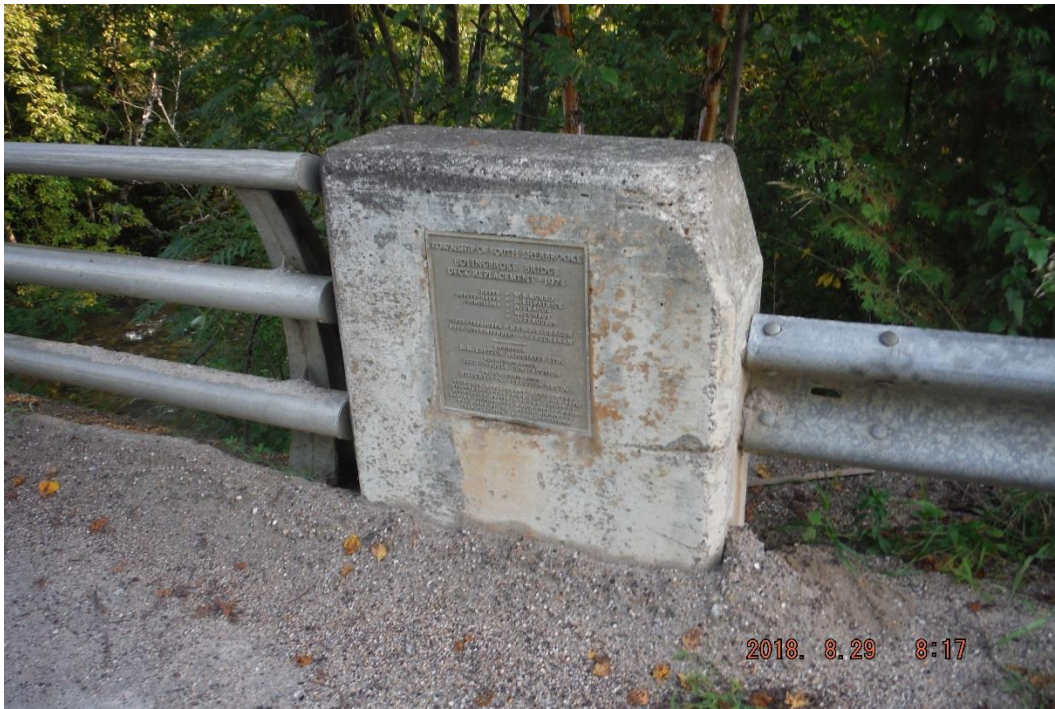
Photo 5: Northwest Concrete End-Post – Medium Scaling, Light Spalling and Light Abrasions

Element Group:	Barriers			Length:	0.9		
Element Name:	Parapet Walls			Width:	0.30		
Location:	NE, NW, SE and SW			Height:	1.00		
Material:	Cast-in-Place Concrete			Count (items):	4		
Element Type:	Concrete End-Post (Interior and Exterior)			Total Quantity:	8.3 m <sup>2</sup>		
Environment:	Severe			Limited Inspection			
Protection System:	None						Perform. Deficiencies
Condition Data:	Units	Exc.	Good	Fair	Poor*		
	m <sup>2</sup>		1.1	3.6	3.6		
Comments:	Medium spalling (0.5 m <sup>2</sup> ), light delamination (0.2 m <sup>2</sup> ), medium to wide cracking (0.2 m <sup>2</sup> ), medium to severe scaling (2.2), light disintegration(0.3 m <sup>2</sup> ), light abrasions (0.2 m <sup>2</sup> ) and hairline to narrow cracking. A benchmark was noted on the southeast end post and a plaque on the northeast						
Recommended Work:		Rehab	X	Replace	Maintenance Needs:		
		1-5 years	X	6-10 years		Urgent	1 year

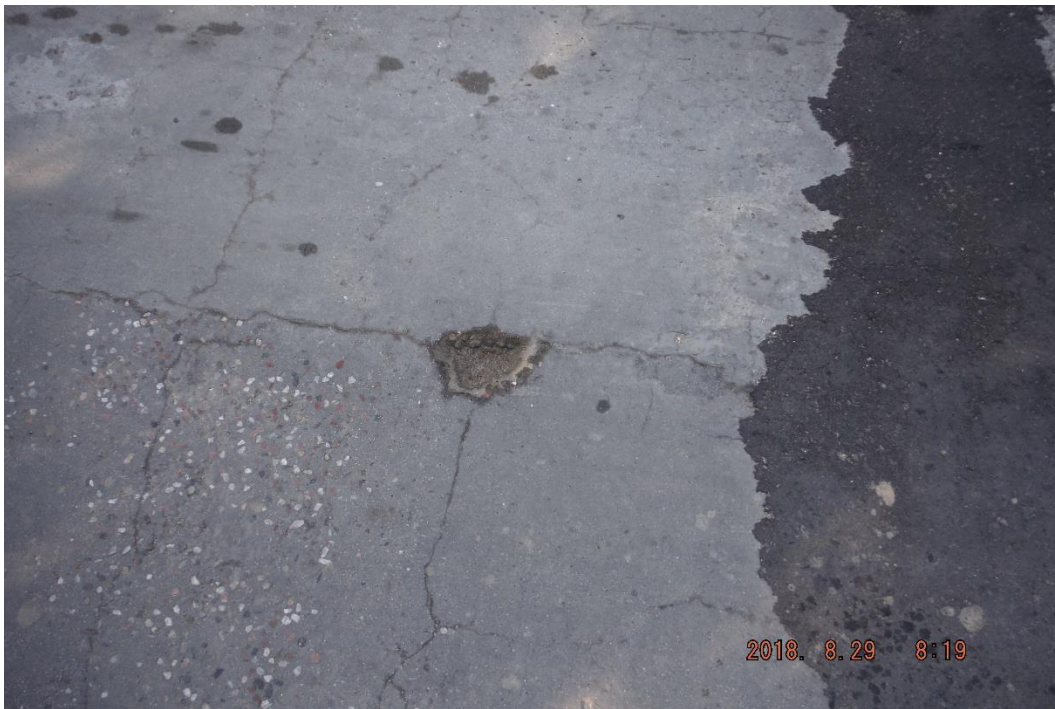
Photo 8: North End of Deck – Severe Delaminations, Light Spalling and Medium to Wide Cracking

Element Data		Bridge Name		Bolingbroke Bridge				
Element Group:	Deck	Length:	37.0					
Element Name:	Deck Top (Exposed Wearing Surface)	Width:	5.7					
Location:	North to South	Height:	N/A					
Material:	Cast-in-Place Concrete	Count (items):	1					
Element Type:	Thin-Slab	Total Quantity:	210.9		m <sup>2</sup>			
Environment:	Severe	Limited Inspection						
Protection System:	None					Perform. Deficiencies		
Condition Data:	Units	Exc.	Good	Fair	Poor*			
	m <sup>2</sup>		64.7	110.0	36.2			
Comments:	The deck was difficult to inspect due to the amount of debris. Severe delaminations (30.0 m <sup>2</sup> ) and wide transverse cracking (5.7 m <sup>2</sup> ), light spalling (0.3 m <sup>2</sup> ), narrow to medium cracking, light scaling and light abrasions (0.2 m <sup>2</sup> ). A detailed deck condition survey is recommended to determine the full extent of deterioration.							
Recommended Work:		Rehab	X	Replace	Maintenance Needs:

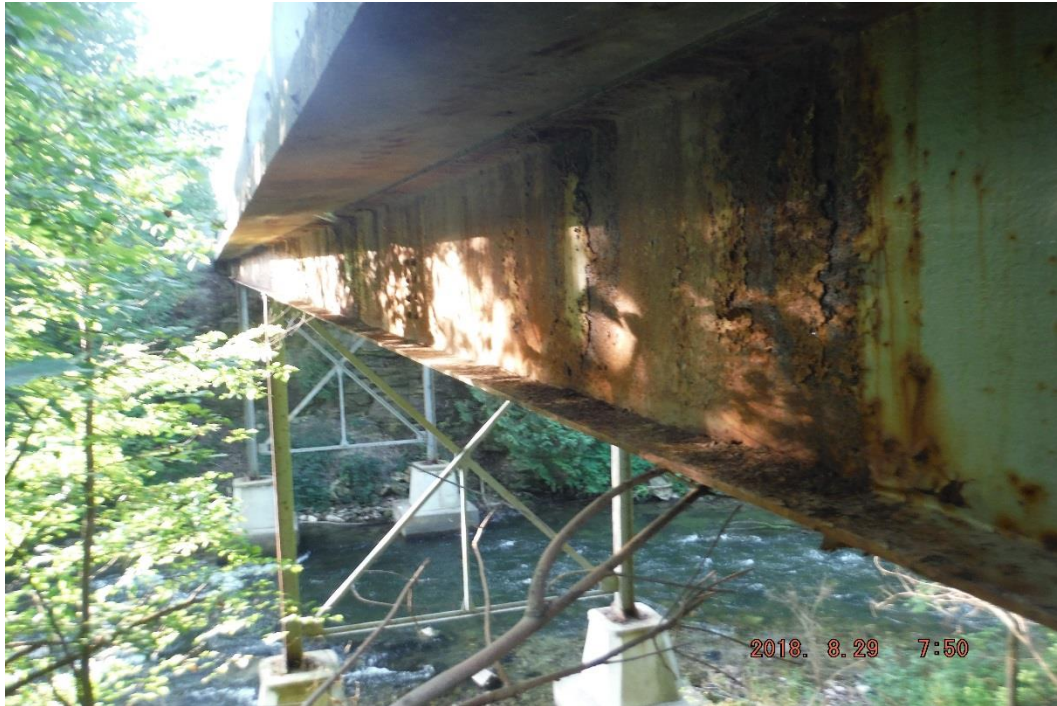
Photo 9: East Exterior Girder – Light to Medium Corrosion

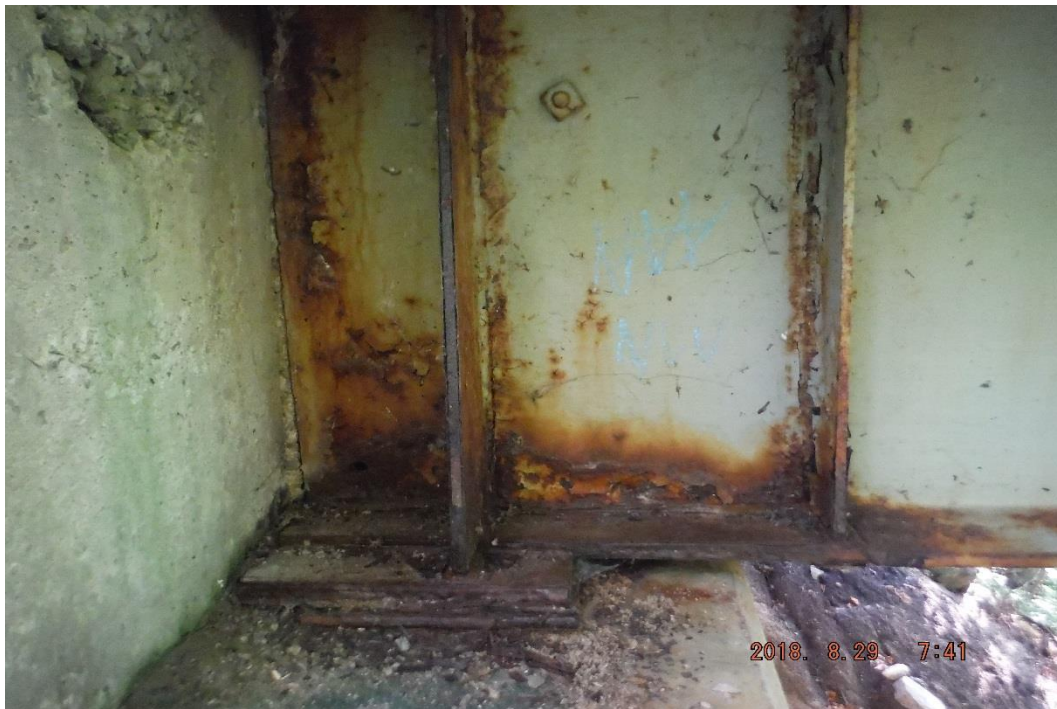
Photo 10: Northwest Girder End and Steel Bearing – Light to Medium Corrosion

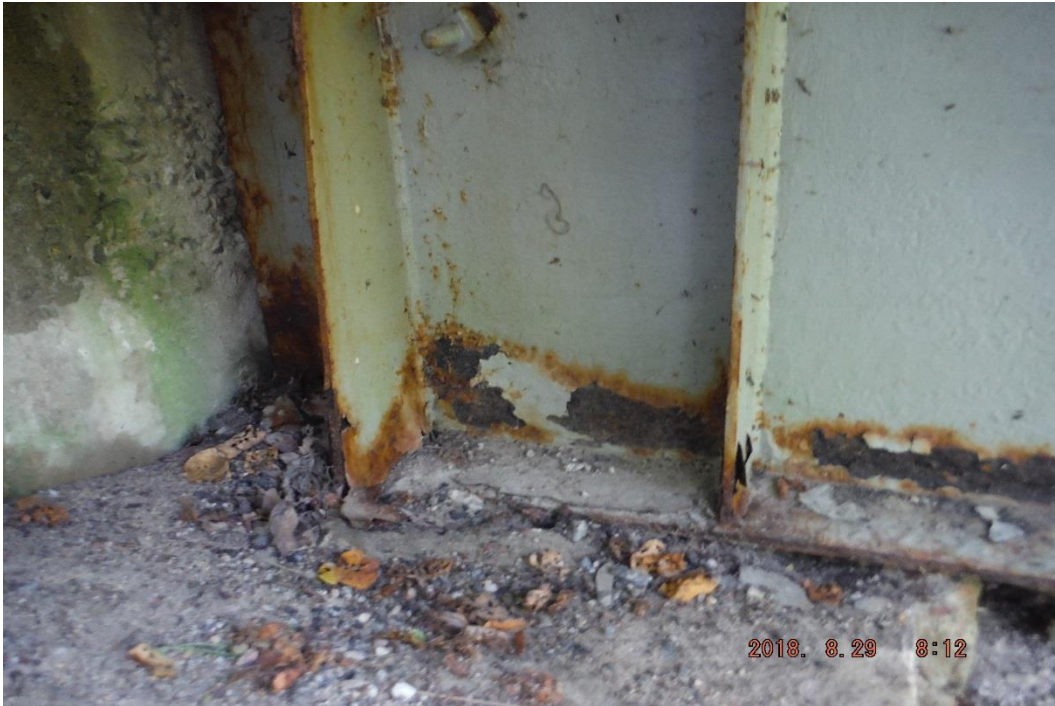
Photo 11: Southeast Girder End – Light Corrosion and Excessive Debris on Bearing Seat

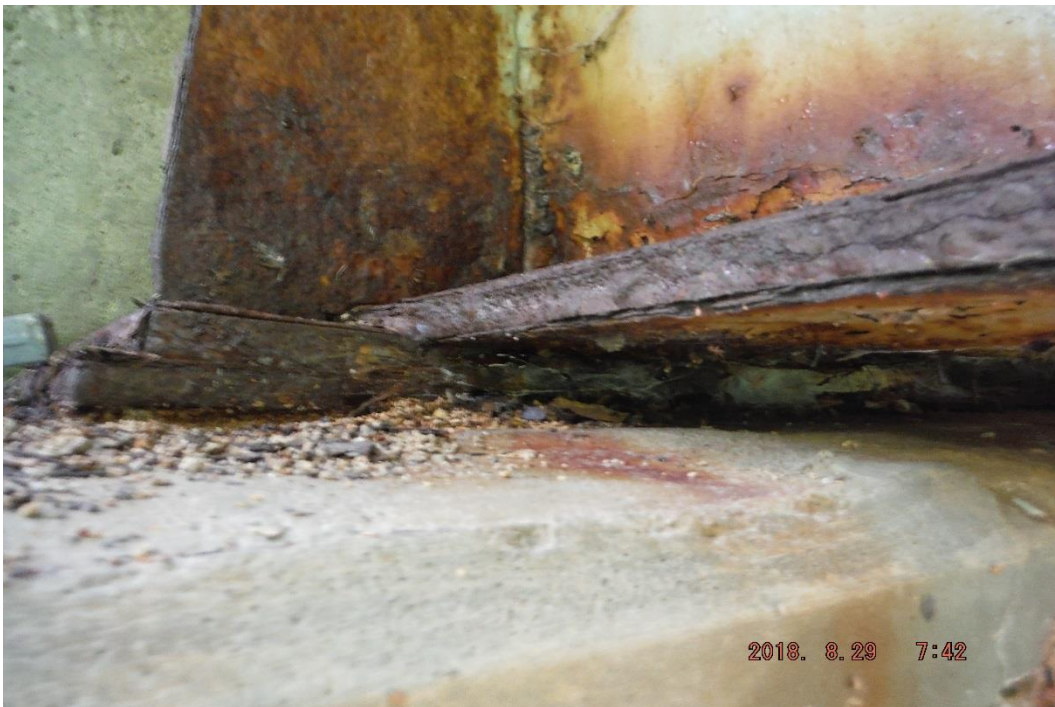
Photo 12: Northwest Bearings – Medium Corrosion and Deformations

<b>Element Group:</b>	Abutments		<b>Length:</b>	N/A		
<b>Element Name:</b>	Bearings		<b>Width:</b>	N/A		
<b>Location:</b>	North and South Abutment Walls		<b>Height:</b>	N/A		
<b>Material:</b>	Steel Plate		<b>Count (items):</b>	4		
<b>Element Type:</b>	Abutment Bearings		<b>Total Quantity:</b>	4 each		
<b>Environment:</b>	Benign		Limited Inspection	X		
<b>Protection System:</b>	None					Perform. Deficiencies
<b>Condition Data:</b>	Units m <sup>2</sup>	Exc.	Good	Fair	Poor*	
				4	0	
<b>Comments:</b>	Limited inspection due to line of sight. The areas of the bearings that were observed evidenced medium to severe corrosion and medium deformations. An enhanced OSIM is recommended in 2020 to properly inspect the bearings.					
<b>Recommended Work:</b>		Rehab	X	Replace	<b>Maintenance Needs:</b>	
	X	1-5 years		6-10 years	Urgent	1 year 2 years
- Replace

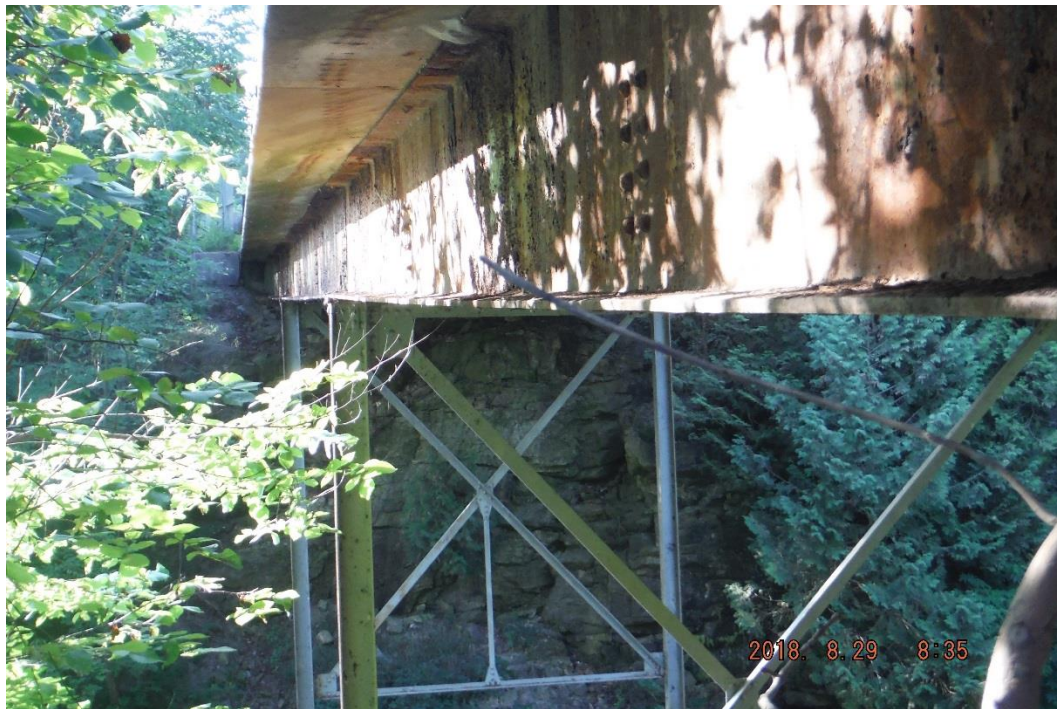
Photo 14: East Exterior Soffit – Light Delaminations and Hairline to Narrow Cracking

- Concrete repair and crack injection

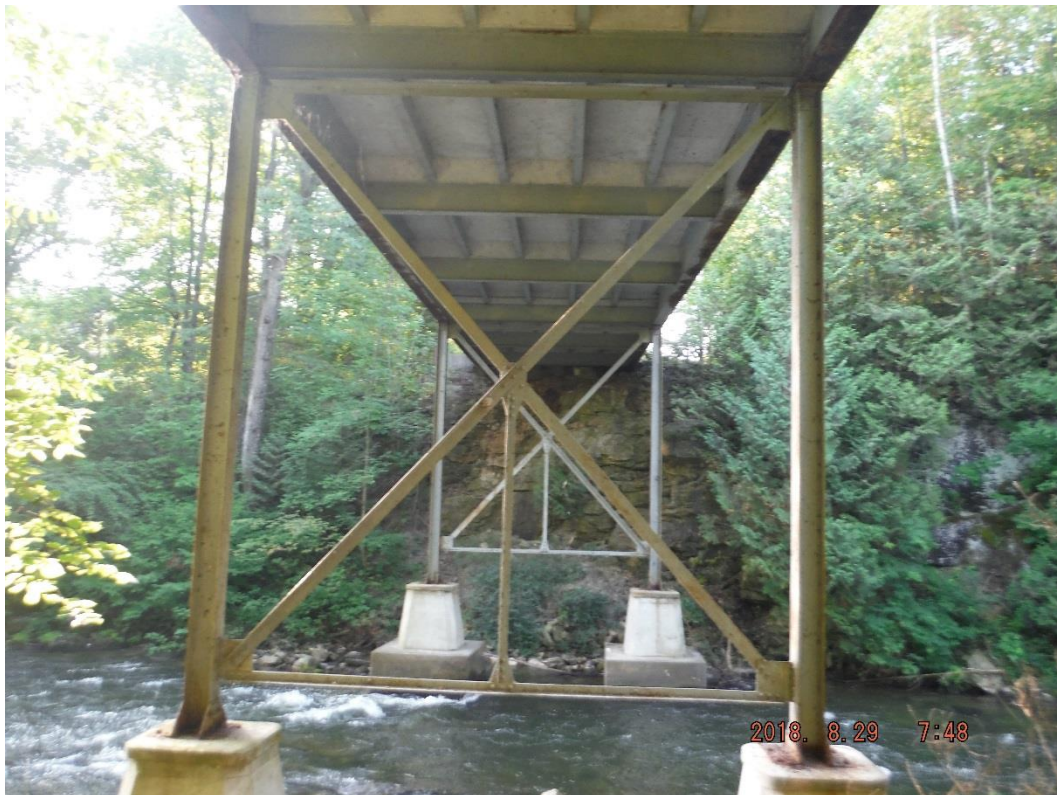
Photo 16: South Pier System – Light to Medium Corrosion

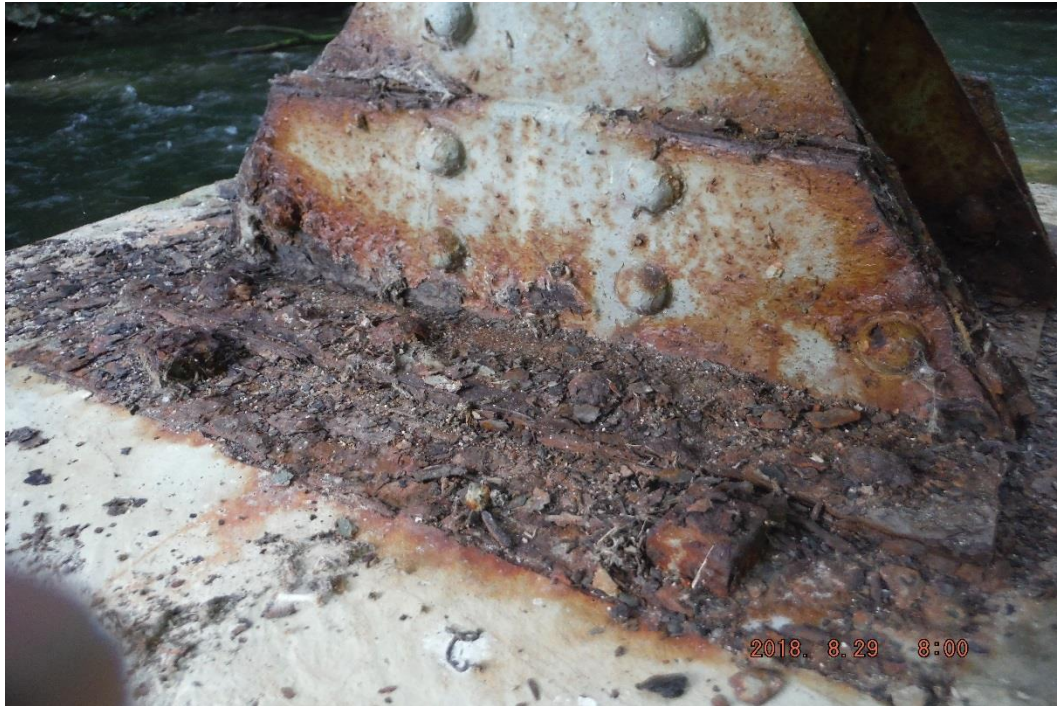
Photo 17: Northwest Pile Bent Connection – Severe Corrosion with Section Loss

Element Group:	Piers		Length:	0.2		
Element Name:	Shafts/Columns/Pile Bents		Width:	0.2		
Location:	NE, NW, SE and SW		Height:	6.0		
Material:	Steel		Count (items):	4		
Element Type:	Pier Column		Total Quantity:	28.8 m <sup>2</sup>		
Environment:	Benign		Limited Inspection			
Protection System:	Paint					Perform. Deficiencies
Condition Data:	Units	Exc.	Good	Fair	Poor*	
	m <sup>2</sup>		16.8	10.0	2.0	
Comments:	Medium to severe corrosion (2.0 m <sup>2</sup> ) localized at the connections to the pedestals, light corrosion observed throughout. Section loss and perforations were evident throughout the connections.					
Recommended Work:	X	Rehab		Replace	Maintenance Needs:	
	X	1-5 years		6-10 years	Urgent	1 year 2 years
- Repair

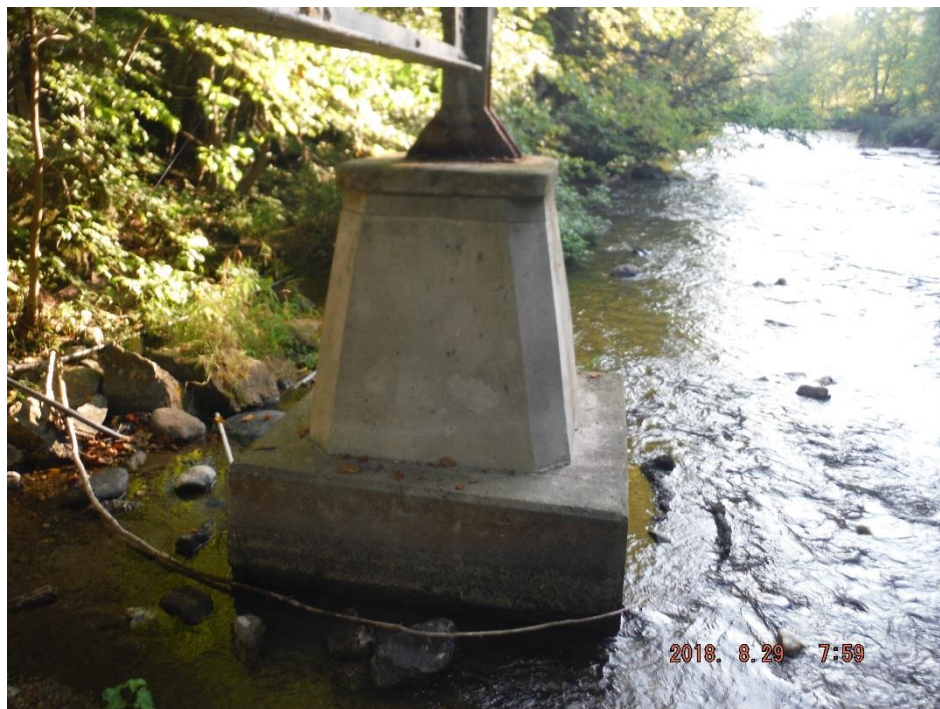
Photo 18: Northeast Pier Footing and Pedestal – Light to Medium Scaling and Medium to Wide Cracking

Element Group:	Piers		Length:	1.0		
Element Name:	Shafts/Columns/Pile Bents		Width:	1.0		
Location:	NE, NW, SE and SW		Height:	1.3		
Material:	Cast-in-Place Concrete		Count (items):	4		
Element Type:	Pier Footing and Pedestal		Total Quantity:	20.8 m <sup>2</sup>		
Environment:	Benign		Limited Inspection			
Protection System:	None					Perform. Deficiencies
Condition Data:	Units	Exc.	Good	Fair	Poor*	
	m <sup>2</sup>		11.4	6.0	3.4	
Comments:	Light to medium delamination (0.8 m <sup>2</sup> ) localized in the footings, medium to wide cracking (0.5 m <sup>2</sup> ), medium to severe scaling (2.1 m <sup>2</sup> ), light scour and erosion.					
Recommended Work:	X	Rehab		Replace	Maintenance Needs:	
	X	1-5 years		6-10 years	Urgent	1 year 2 years
- Repair

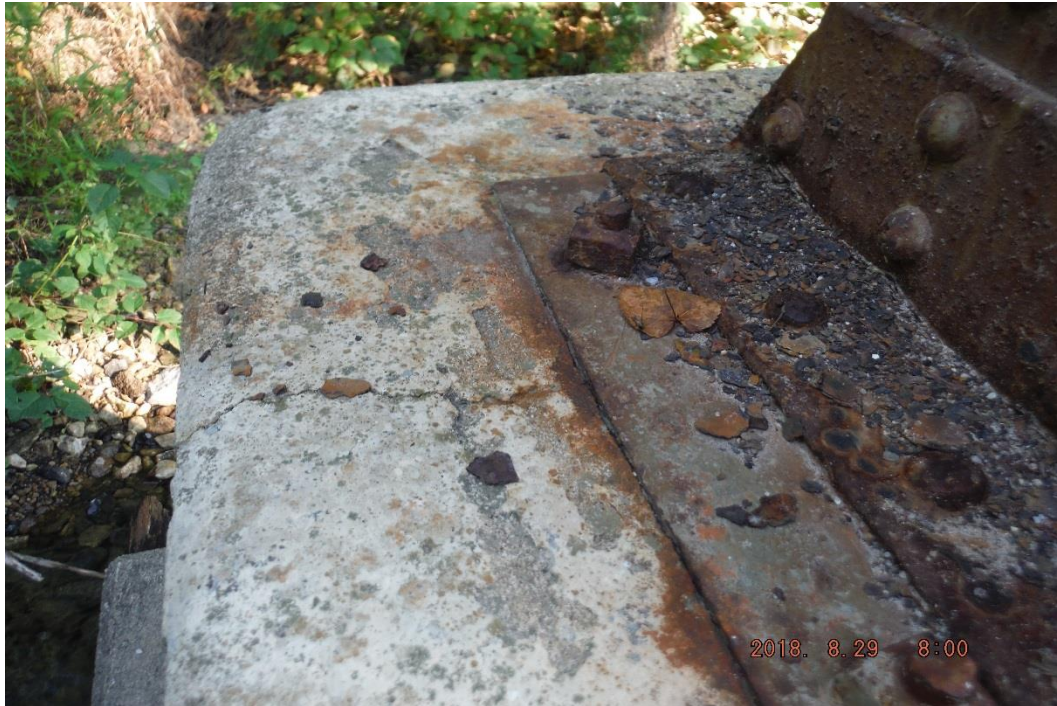
Photo 19: Northeast Pier Pedestal and Bent Connection – Wide Crack and Medium to Severe Corrosion

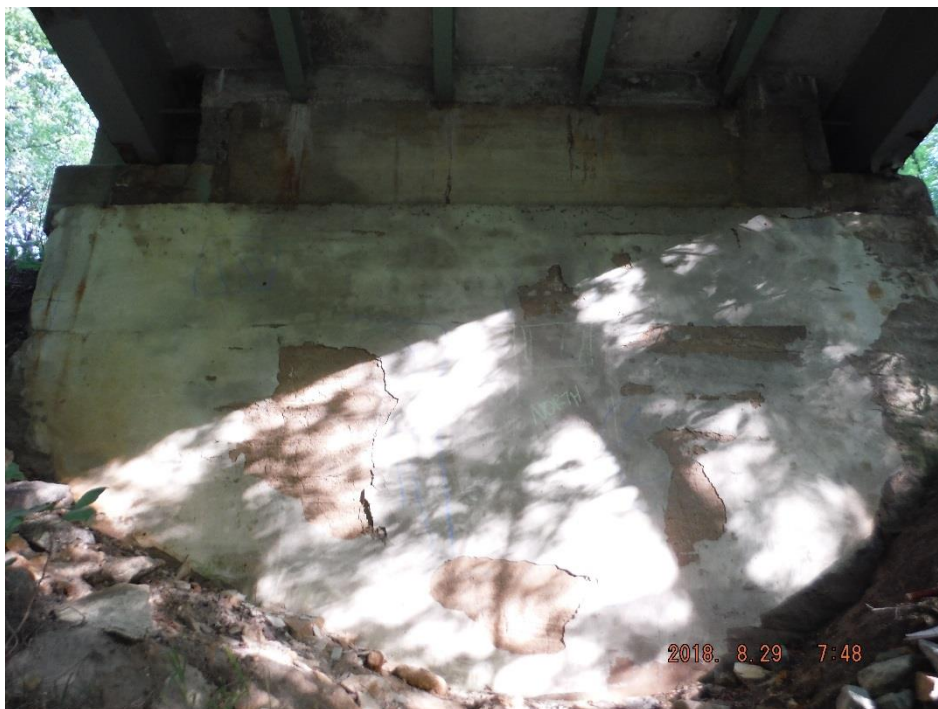
5.8	11.3	
<b>Comments:</b>	The previous patchwork has debonded from the wall. Severe delaminations (4.9 m <sup>2</sup> ), medium to severe spalling (3.5 m <sup>2</sup> ) and light to medium cracking throughout. The northeast corner exhibited severe scaling (2.0 m <sup>2</sup> ), severe disintegration (0.9 m <sup>2</sup> ) and erosion.					
<b>Recommended Work:</b>	X	Rehab		Replace	<b>Maintenance Needs:</b>	
	X	1-5 years		6-10 years	Urgent	1 year 2 years

Photo 20: North Abutment Wall – Severe Delaminations, Wide Cracking, Severe Scaling and Disintegration

- Concrete repair and crack injection

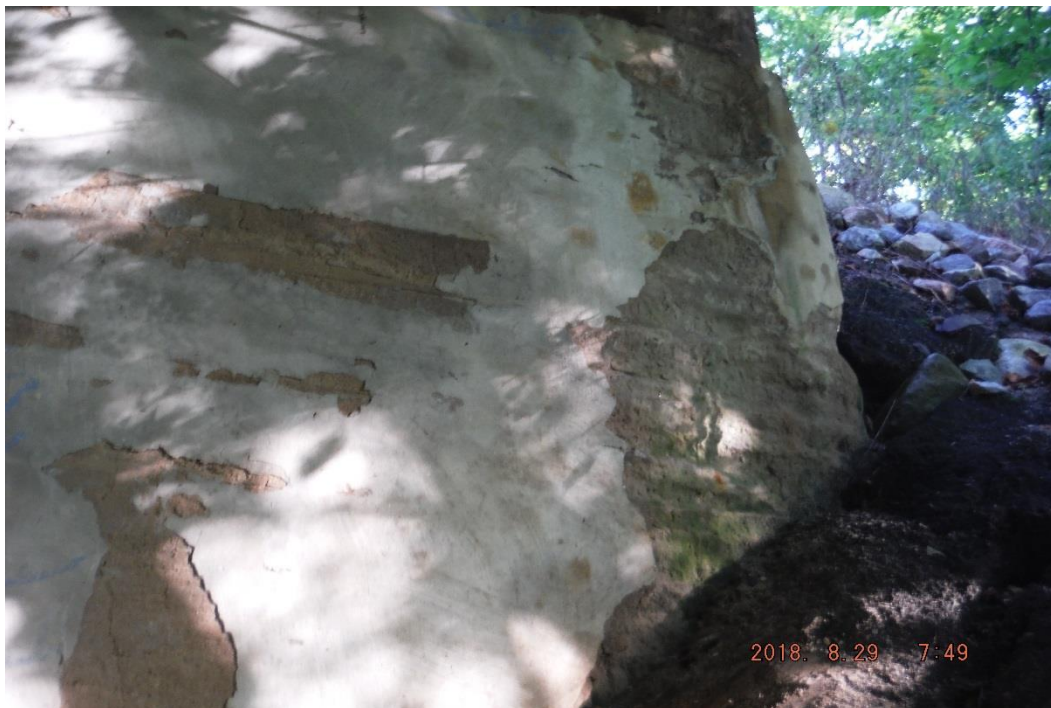
Photo 21: North Abutment on the East End – Severe Delaminations and Severe Erosion and Disintegration

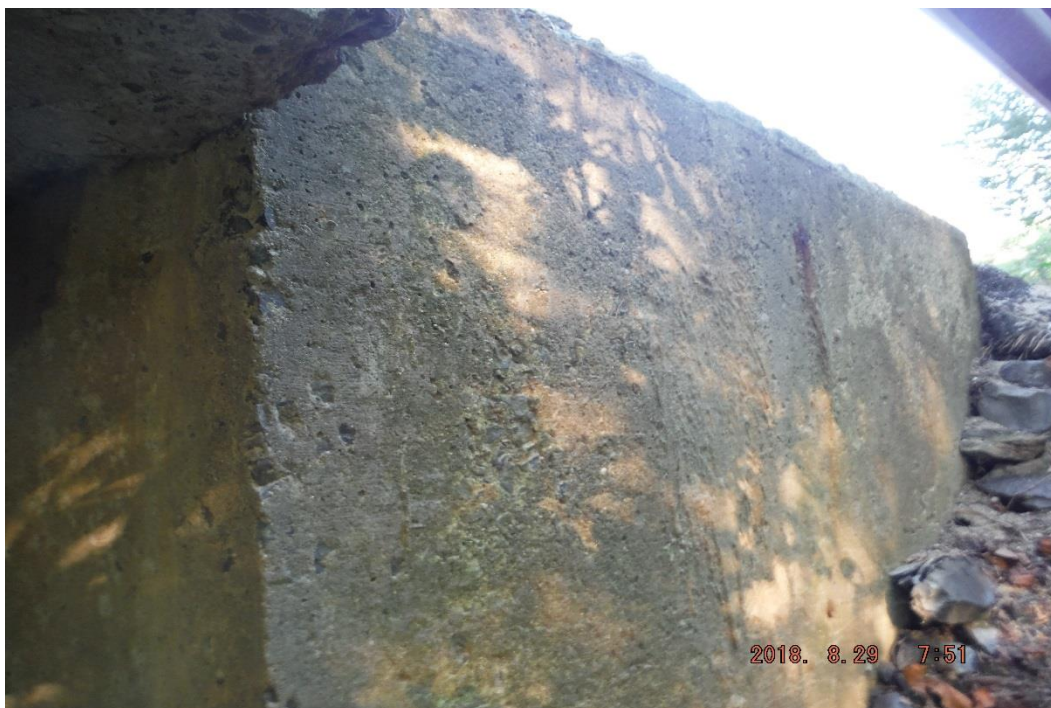
Photo 22: Southwest Wingwall – Light to Medium Scaling

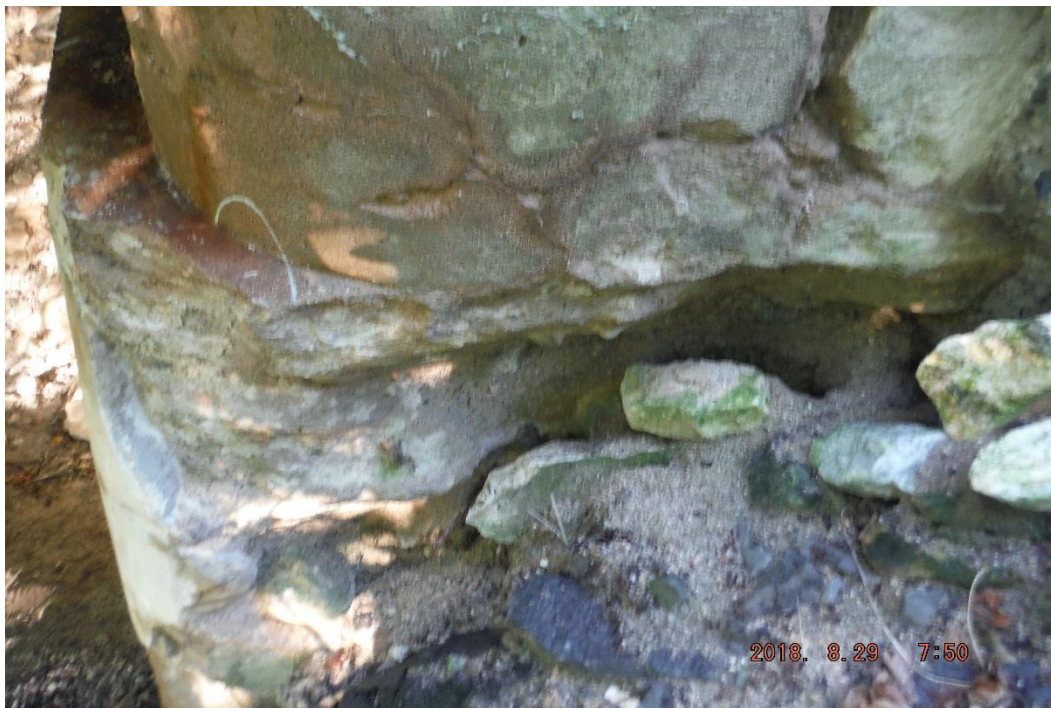
Photo 23: Northeast Wingwall – Severe Erosion, Scaling and Disintegration
